Slope Stabilization and Repair Solutions for Local Government Engineers

David Saftner, Principal Investigator

Department of Civil Engineering
University of Minnesota Duluth

Research Project
Final Report 2017-17

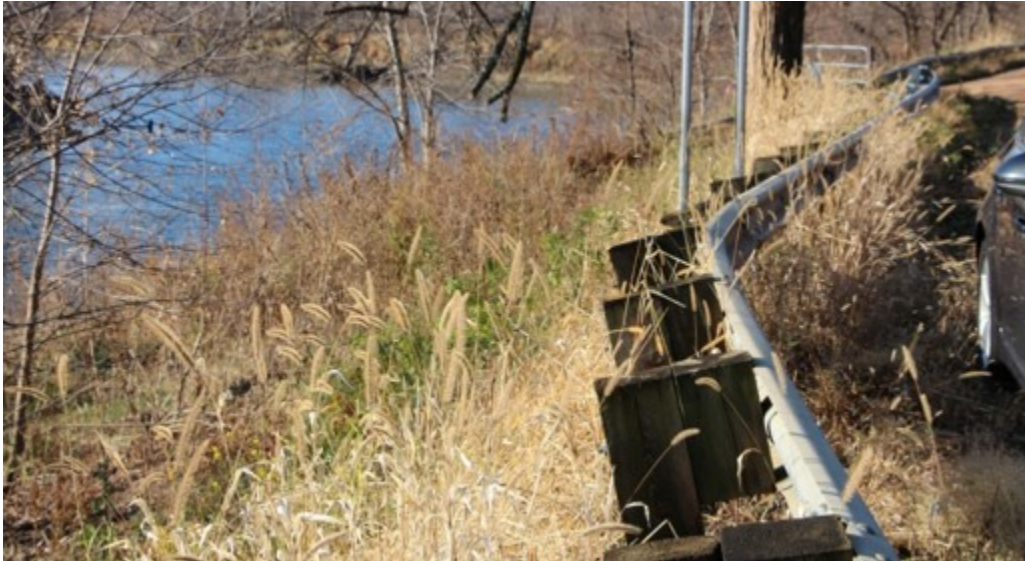
The Carver County site was located on County Road 40, on the Minnesota River north of Belle Plaine, MN. The location was recommended by the county highway department operations manager in the initial survey. Researchers noted some minor pavement distress. The guardrails along the road bend were pitched slightly from vertical, indicating soil creep, as shown in Figure 18. Site cover was primarily tall grass.

Figure 18: Carver County site slope, crooked guardrails indicate soil creep

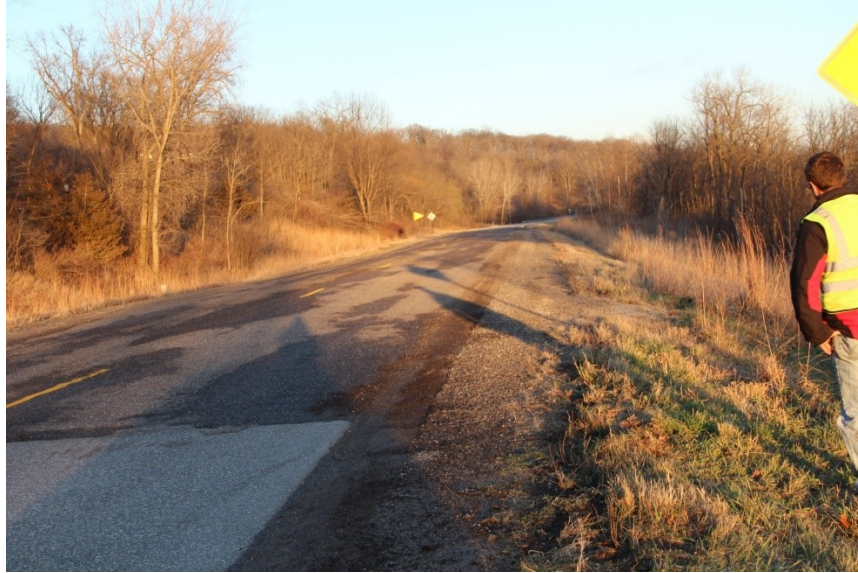
The Fillmore County site was located on CSAH 5, approximately 5 miles southwest of Chatfield, MN. The county engineer identified the location in the initial survey. The site was characterized by significant pavement distress, as illustrated in Figure 19. The Middle Branch Root River was near to toe of the slope. Investigators noted a large failure with clear scarp lines, characteristic of rotational slide failure, leaving vertical faces 1.5 to 2 feet tall (Figure 20 and Figure 21). The site was covered by tall grass. Topsoil extended 6 to 12 inches below the surface.

Figure 19: Pavement distress at Fillmore County Site

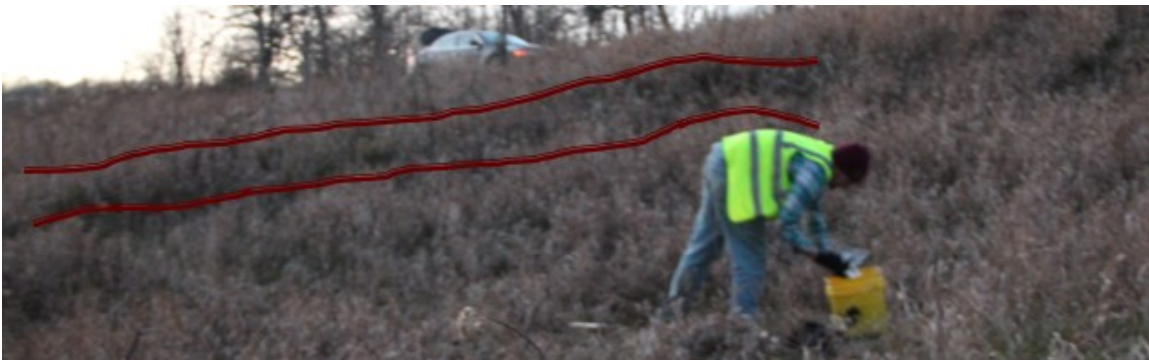
The soil was brown, fine-grained silty sand. Researchers conducted field sampling and *in situ* testing in an area inside and outside the failure region. S_u values ranged from 1.25 to 1.75 tsf. DCP testing results indicated that the top several blows (20 to 30 cm) had a relatively low resistance to penetration, with deeper material having a higher resistance. The soil's correlated N_{60} values were approximately 4 to 5 blows per foot. The geology of the site was weathered material on bedrock (Ojakangas, 2009; Hobbs & Goebel, 1982), consistent with soil observed. With the toe of the slope near a stream, the researchers identified groundwater and drainage conditions as a concern for this slope. As with several other slopes studied, the side of the road near a stream is failing, illustrating the importance of drainage. The field investigators did not observe any slope stabilization methods in place.

Figure 20: Clear rotational failure visible behind researcher at Fillmore County site

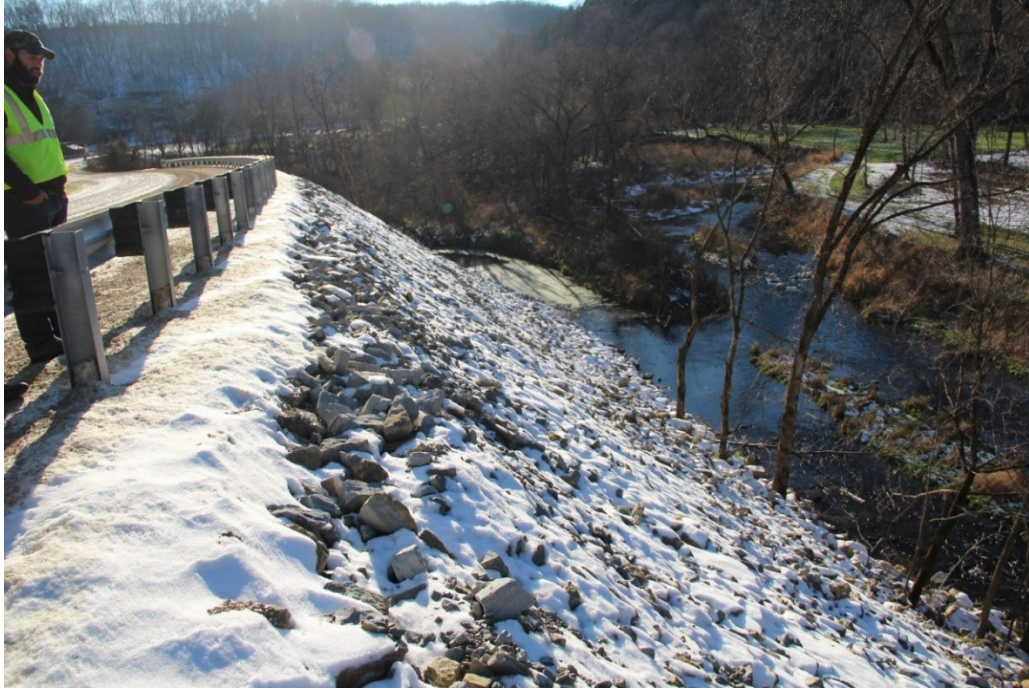
Coarse rip rap covered the entire face of the slope. This is a common repair approach the county uses for slope failures. The plans specified a quarry-run rip rap, and grass seeding to cover. The county typically does not conduct a geotechnical investigation prior to implementing stabilization methods because maintenance teams have demonstrated success with the "rip-rap cover" method.

Figure 22: Houston County site slope

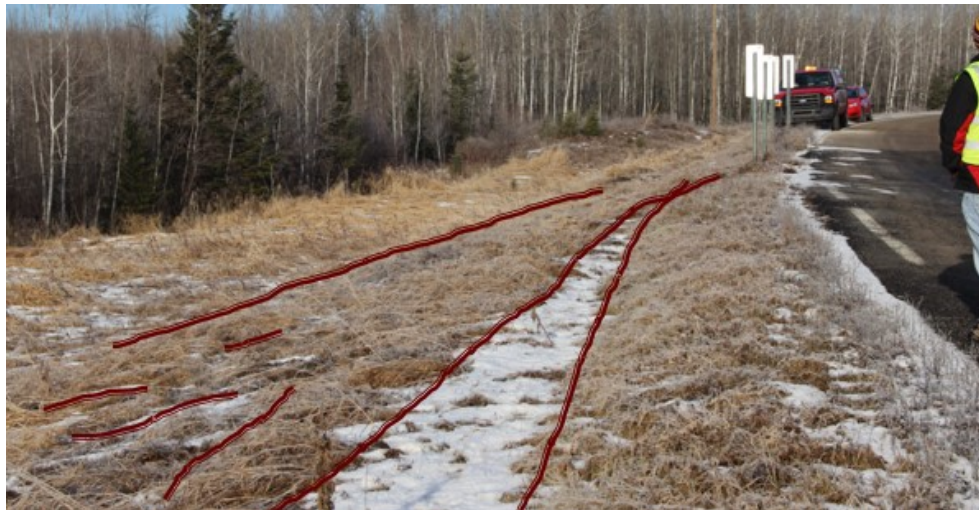
The research team performed a field investigation at the County Road 8 site, shown in Figure 24. Researchers were informed that, like several other slope failures in the region, slope stability issues were first noted 15 to 20 years earlier; the pavement was repaired, but no slope stabilization methods were considered. The slope featured multiple small failures. The site was characterized by visible creep failure patterns and evidence of pavement repair.

Figure 24: Koochiching County site with visible soil creep

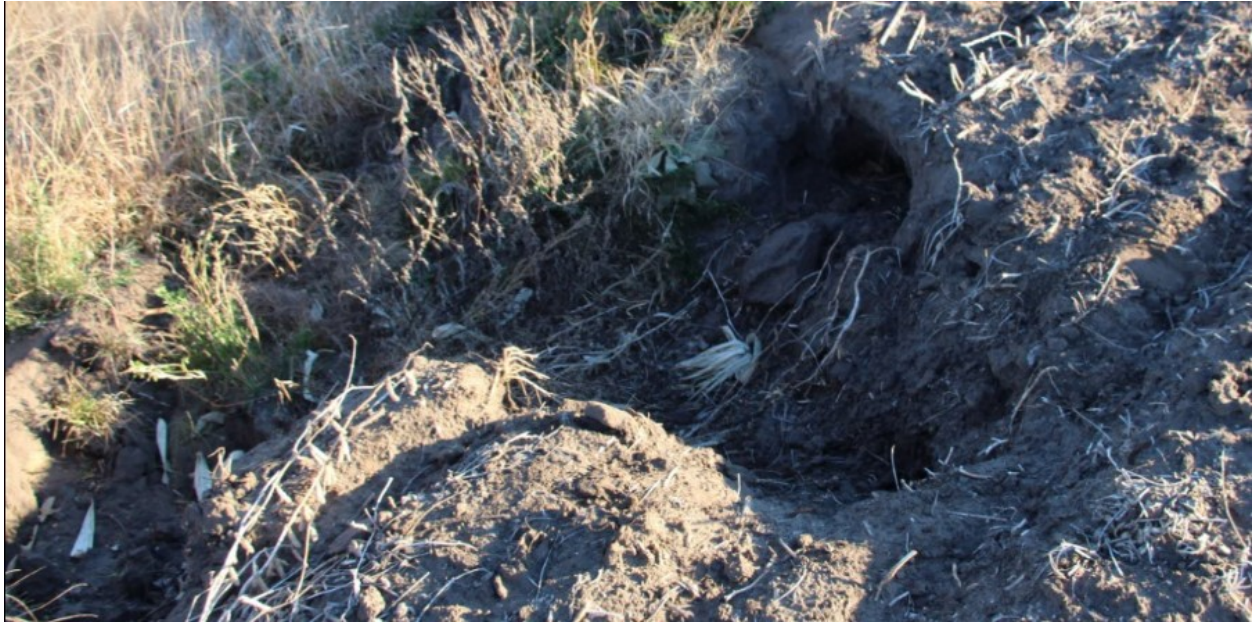
Field testing and soil sampling was conducted near the erosion-induced slope failure. Soil encountered during testing was light brown to brown fine to medium-grained sand with trace gravel. The soil had correlated N_{60} values ranging from 5 to 7 blows per foot. Pocket penetrometer testing at the failure indicated S_u values of 1.25 to 2 tsf. Ojakangas (2009) and Hobbs and Goebel (1982) identified the geology of the region as sediment from the Minnesota River, consistent with observed soil onsite. The county engineer provided project documents from recent roadwork (grading in 2013 and surfacing in 2014). Ground cover did not seem to influence slope stability at the failure location. Landowner property boundaries and right-of-way concerns caused geometry limitations next to planted fields. Areas with naturally forested uphill cover did not show signs of failure. Water is the driving force of the failure.

Figure 26: Erosion at edge of planted field causes slope failure in Lac Qui Parle Co.

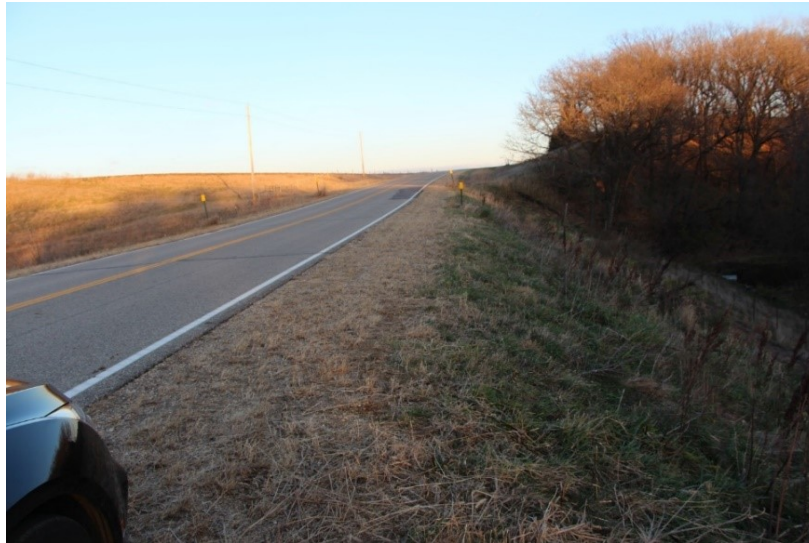
types. The nearby stream indicated groundwater concerns. Slope steepness, landowner and right-of-way considerations, and groundwater were issues on this site.

Figure 28: Murray County site slope after reconstruction with visible pavement repair

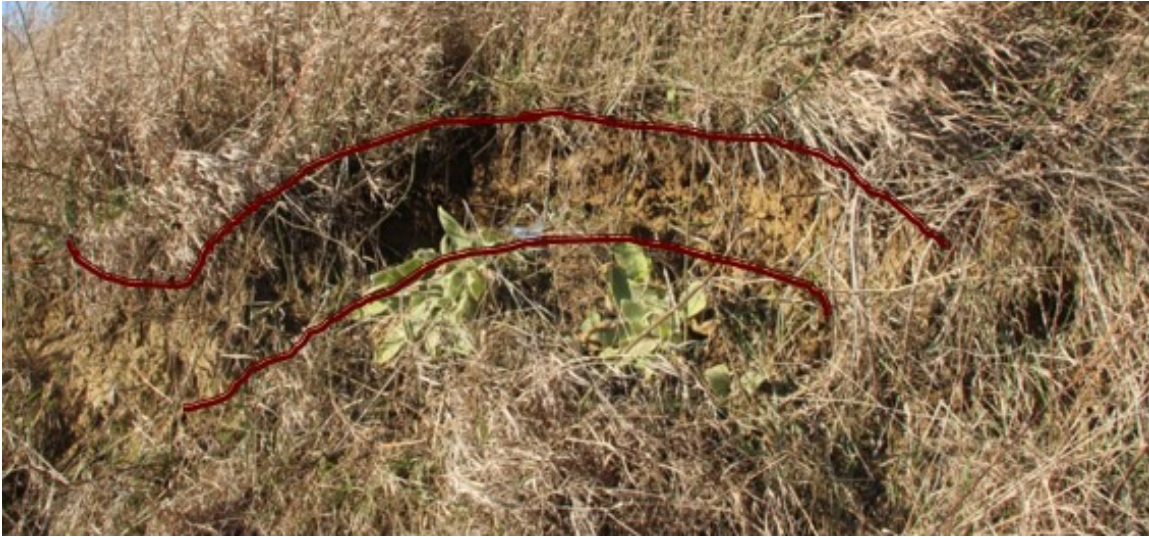
Observed soil was light brown silty sand. Sampling and *in situ* testing were conducted both inside and outside of the visible failure area. Results of DCP testing indicated roughly the top half of the DCP depth had low resistance to penetration, while the second half of the test depth exhibited more resistance. The failed soil had a correlated average N_{60} value of 2 blows per foot, and the soil that did not exhibit visible failure had an average N_{60} value of 3 blows per foot. Ojakangas (2009) and Hobbs and Goebel (1982) described the geology of the region as glacial drift.

Figure 30: Rotational failure scarp at Olmsted Co. site

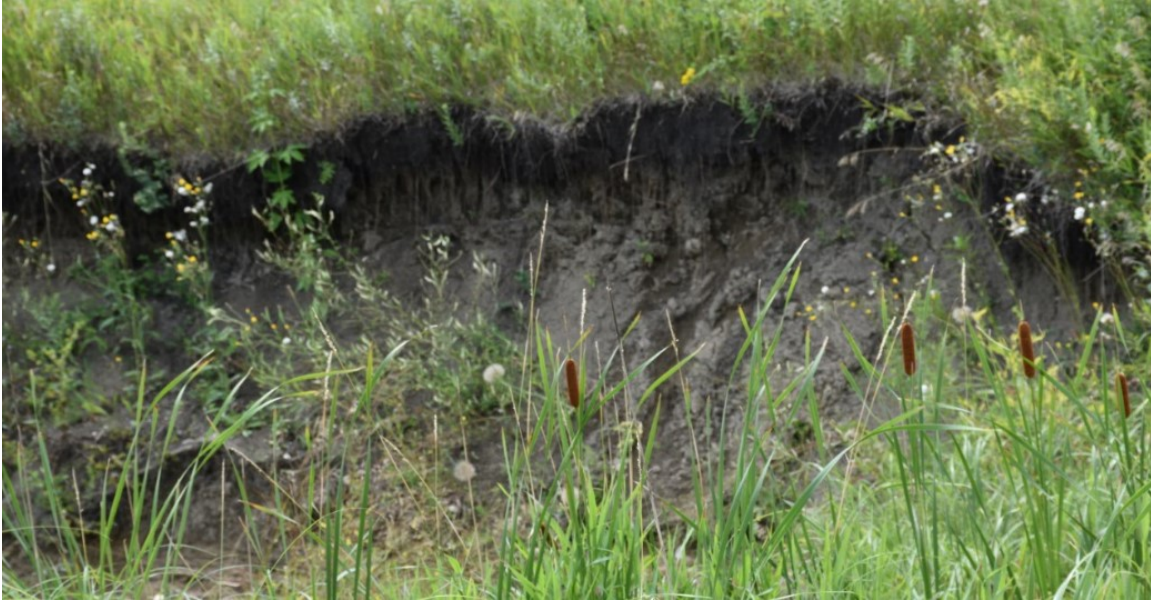
The Pennington County site was located on MN-32, approximately 1 mile south of Thief River Falls, MN. The site was identified by the county engineer in the initial survey. The site was characterized by significant rotational failure, as illustrated in Figure 31. The Red Lake River was near the site and standing water was observed at the toe of the slope. The failure was characterized by clear scarp lines leaving vertical faces 3 to 5 feet tall. The site was covered with tall grass.

Figure 31: Pennington County site slope, clear rotational failure

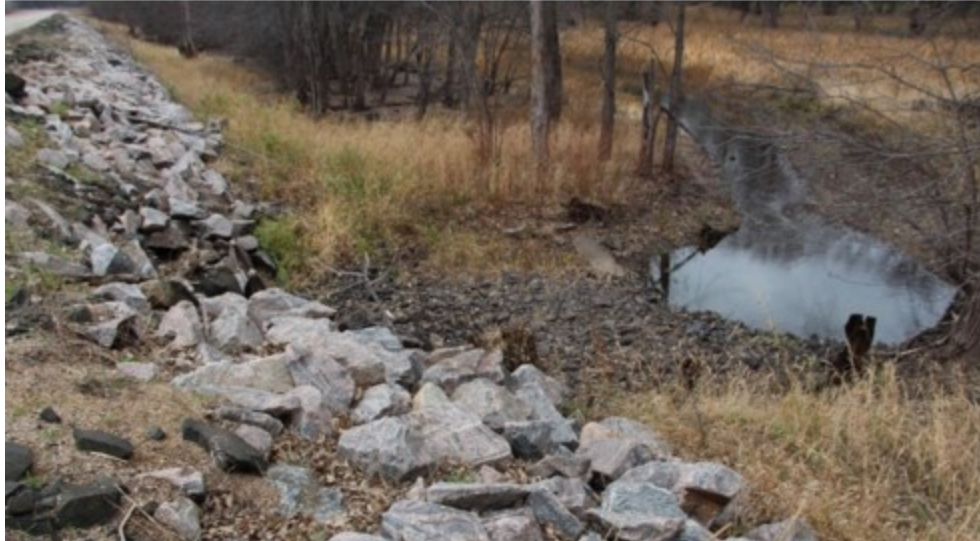
The Redwood County site was located on CSAH 11 south of the Minnesota River near Franklin, MN. The failure was identified by evidence of pavement repair. The county engineer noted the site location in the initial survey. The failed side of the road was covered with coarse aggregate and rip rap, as shown in Figure 32. The opposite, although apparently steeper, did not show signs of failure or stabilization attempts, as pictured in Figure 33. Site surface cover was thick grass, geosynthetic fabric, and rip rap. *In situ* testing and sample collection were conducted at the steeper, southern site.

Figure 32: Failed (east) side of Redwood County site slope and nearby stream

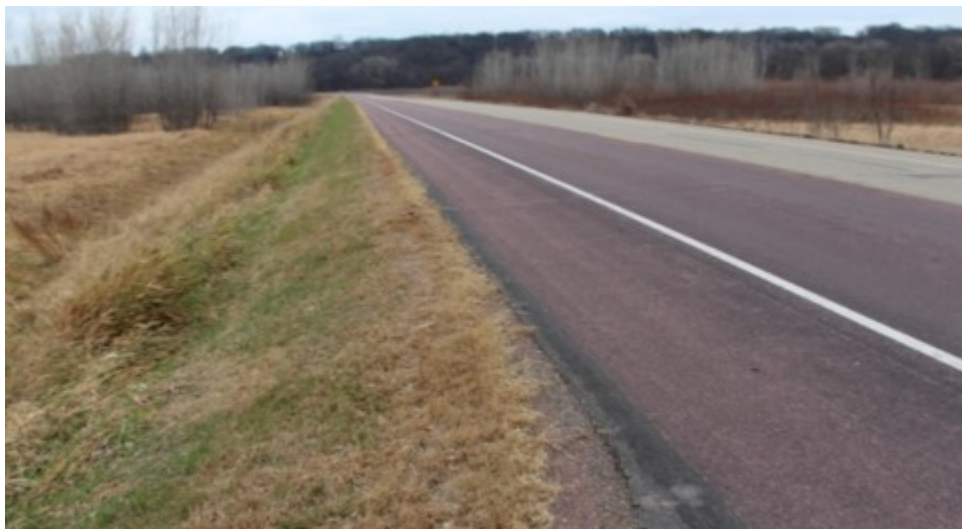
Soil observed was dark brown fat clay. Some sand seams were noted during sampling. Average undrained shear strength values were 0.5 tsf. DCP test results indicated poor penetration resistance in the top 1 to 1.5 feet, then a notably higher resistance deeper. The average N_{60} values for the site ranged from 4 to 5 blows per foot. Geologically, the site was composed of sediment from the Minnesota River and glacial till (Ojkangas, 2009). River sediment likely caused the sand seams. No standing water was observed in the ditch; however, a stream was present near the toe of the slope. Groundwater drainage conditions are likely a stability concern. Rip rap cover was evidence of slope stabilization attempts. Older rip rap indicates the site has been repeatedly repaired.

Figure 33: Opposite (west) slope, no observed failure at Redwood Co. site

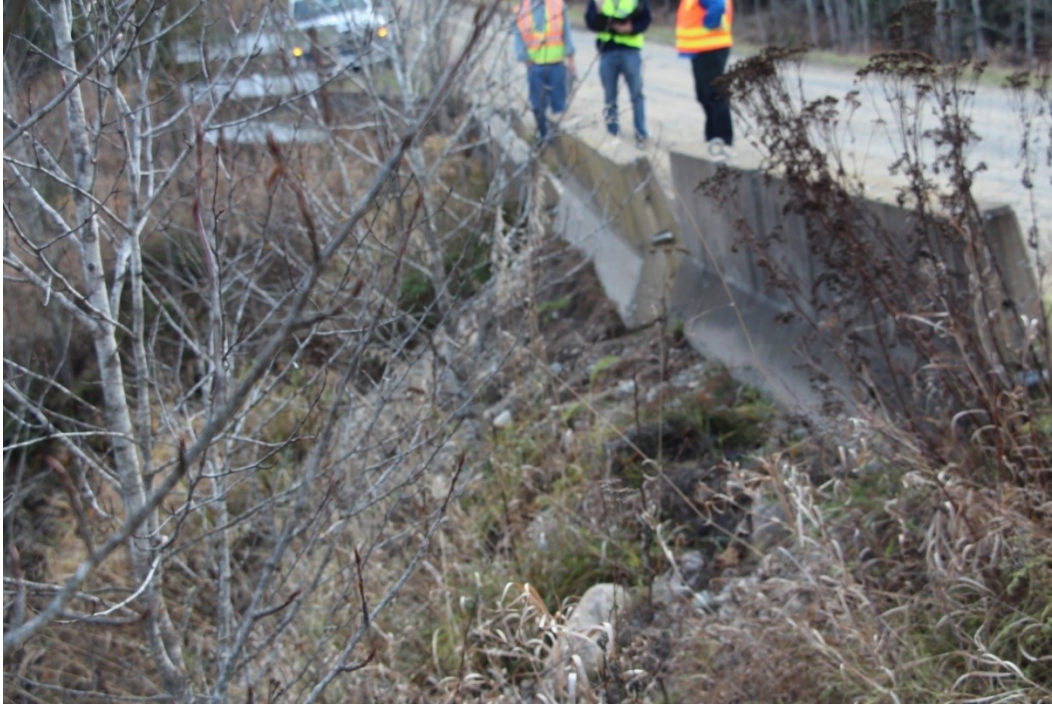
The site representing St. Louis County, pictured in Figure 34, was located on County Road 535 near Greany, MN. The site was identified by a severe failure of the road embankment over a culvert and displacement of concrete roadway barriers over the failure. Slope damage was due to culvert failure and erosion causing the toe of the slope to fail. The county maintenance engineer, and regional maintenance superintendent met the project team onsite to discuss the project history. Site cover was grass, brush and small trees.

Figure 34: St. Louis County slope and displaced concrete barriers

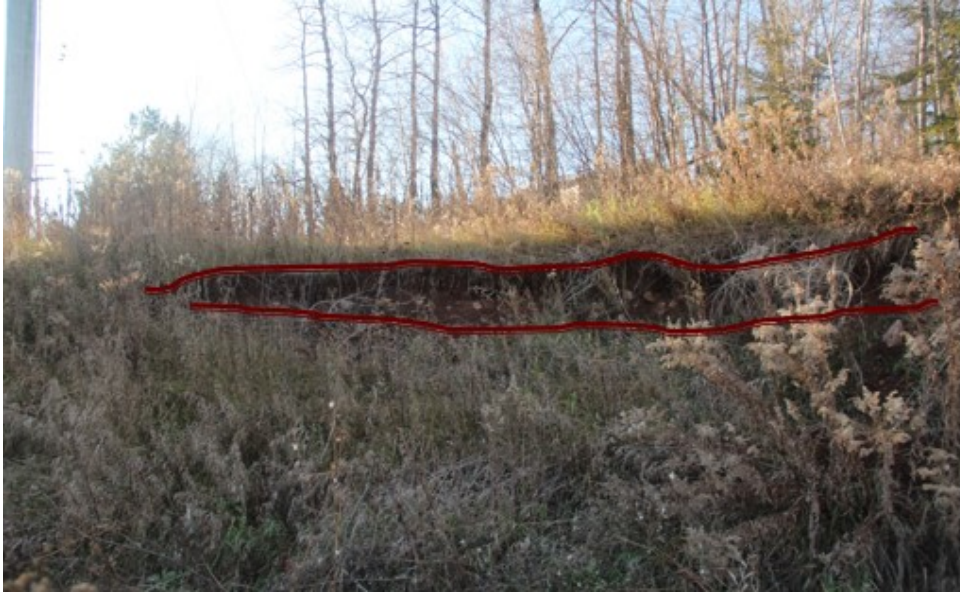
A MnDOT engineer and project adviser identified another slope failure in St. Louis County, located in West Duluth on Grand Avenue. The failure is shown in Figure 35. The slope was covered with grass and the top of the slope was wooded.

Figure 35: West Duluth site slope

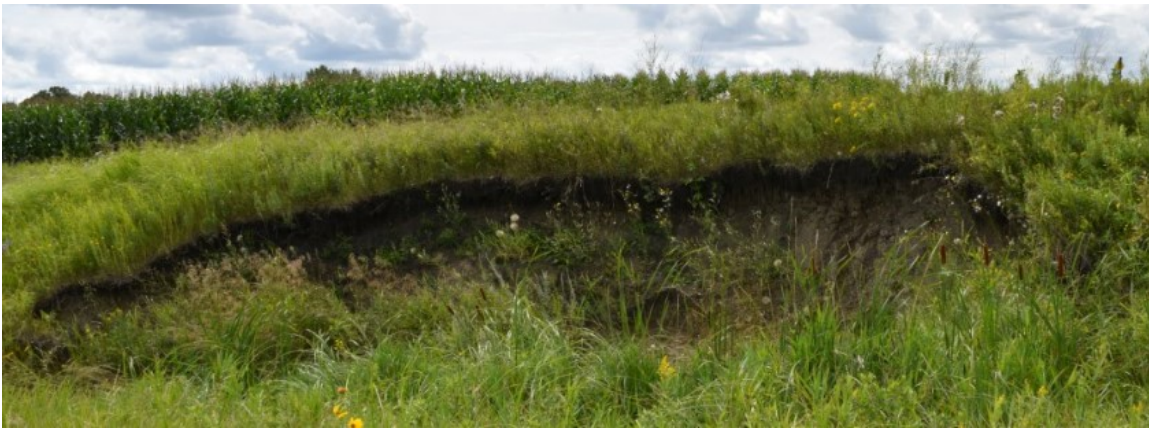
Figure 47: Example of Scenario #1 from Pennington Co., MN

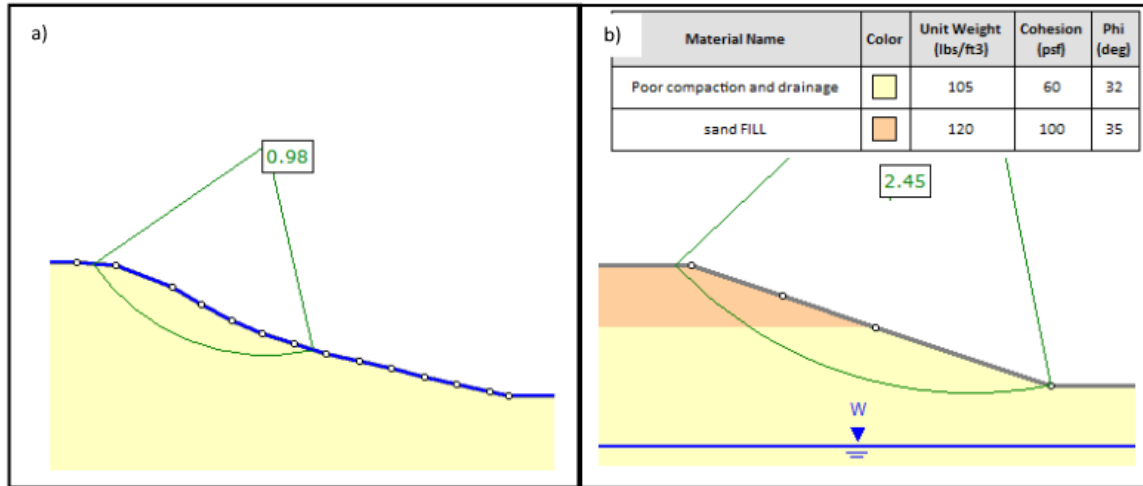
Figure 48: Model representing Scenario #1 a) with observed failure characteristics, and b) after implementing recommended stabilization methods

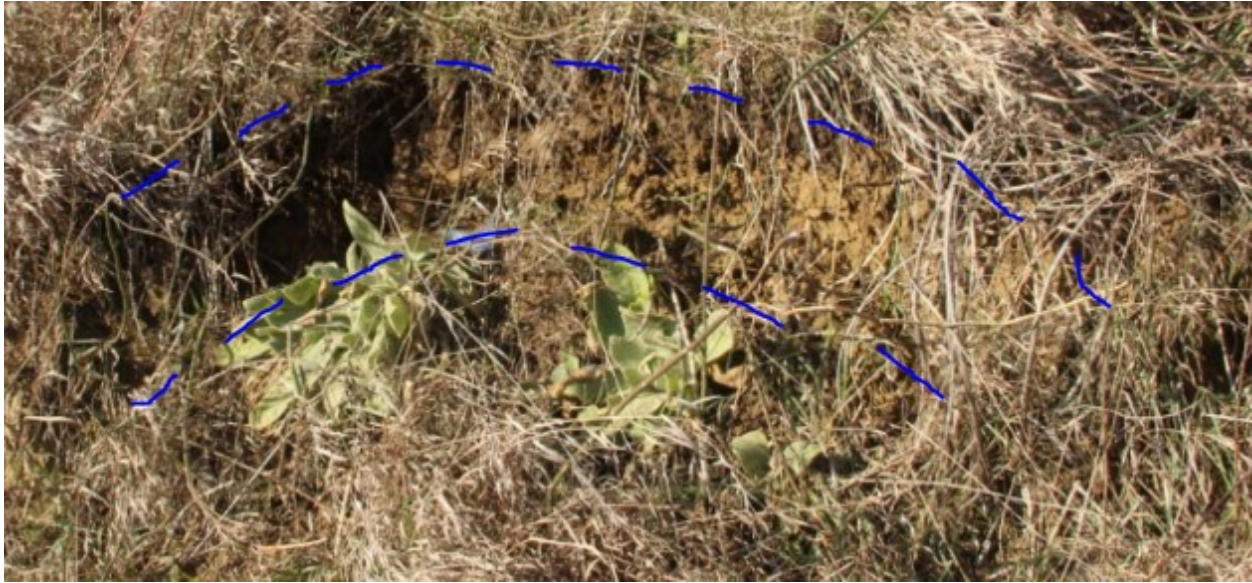
Figure 49: Example of Scenario #2 from Olmsted Co., MN

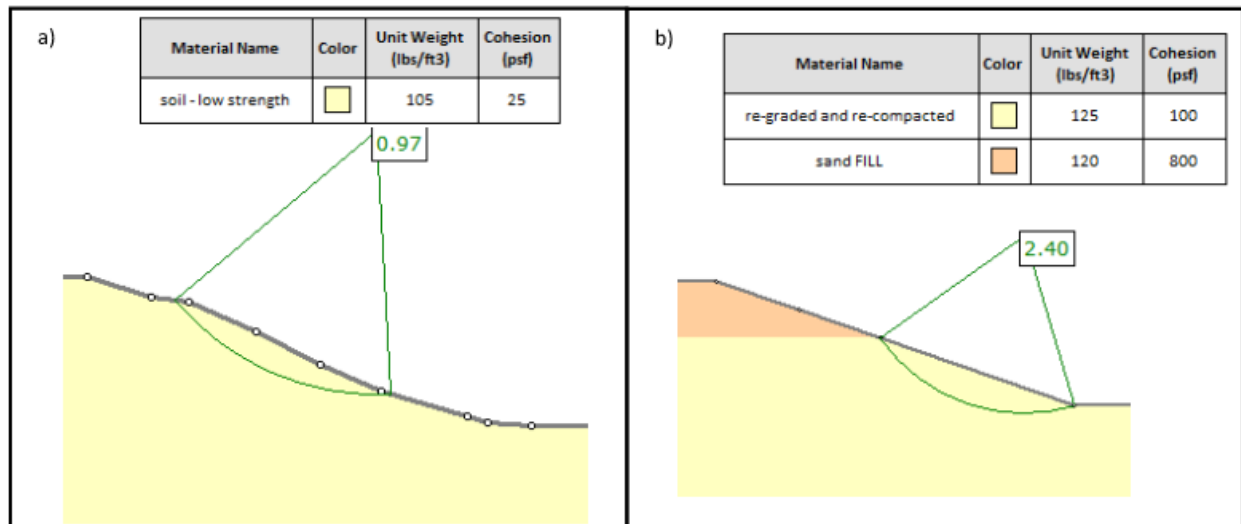
Figure 50: Model representing Scenario #2 a) with observed failure characteristics, and b) after implementing recommended stabilization methods

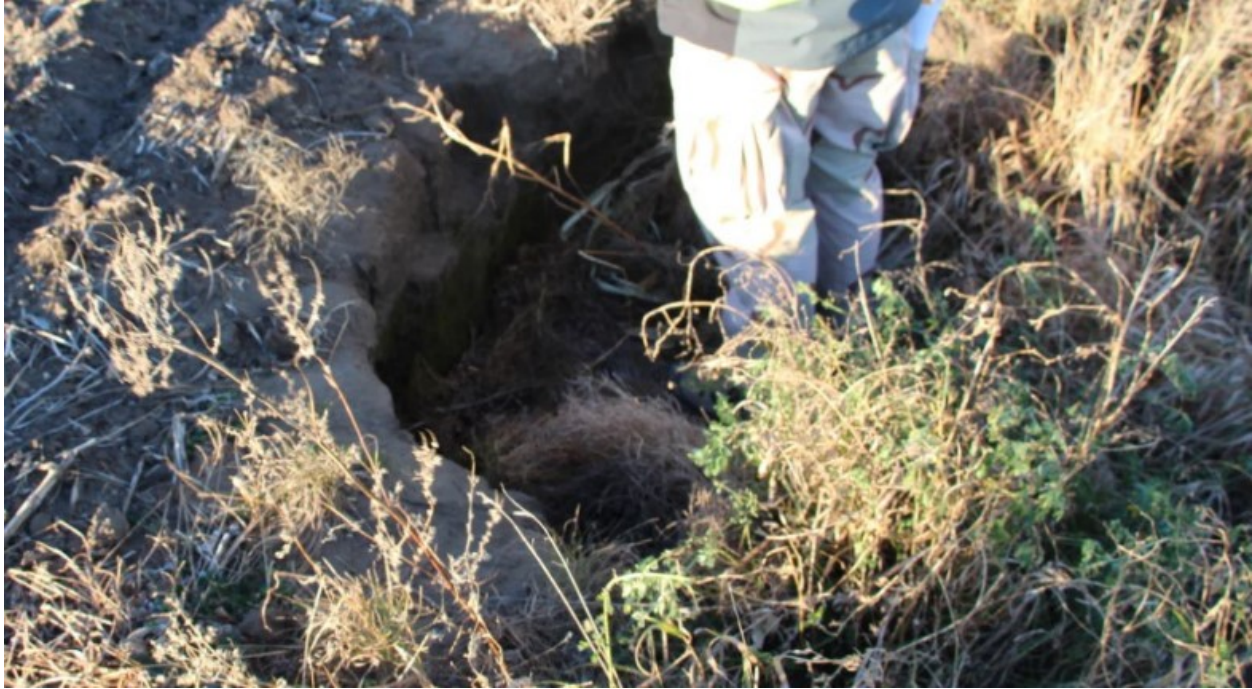
Figure 51: Example of Scenario #4 (from Lac Qui Parle Co. site)

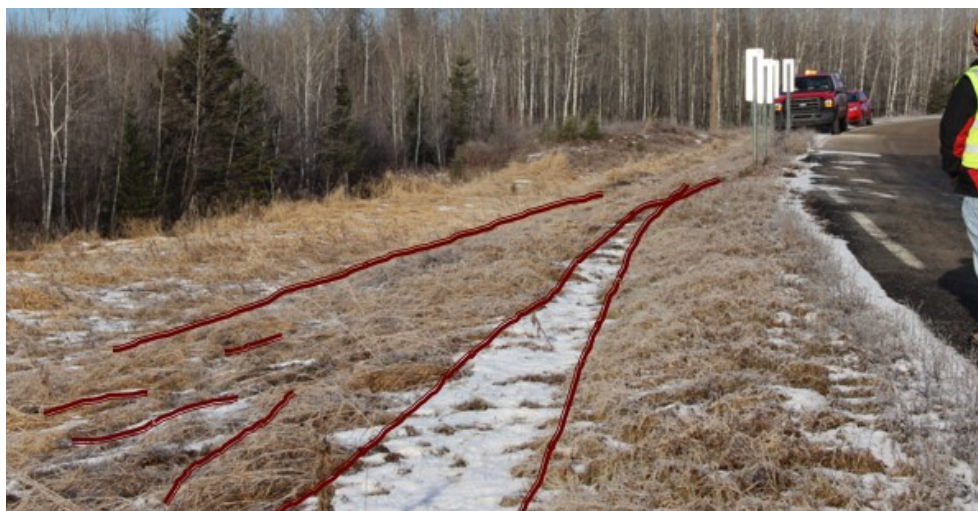
Figure 52: Example of Scenario #5 (from Koochiching Co. site)

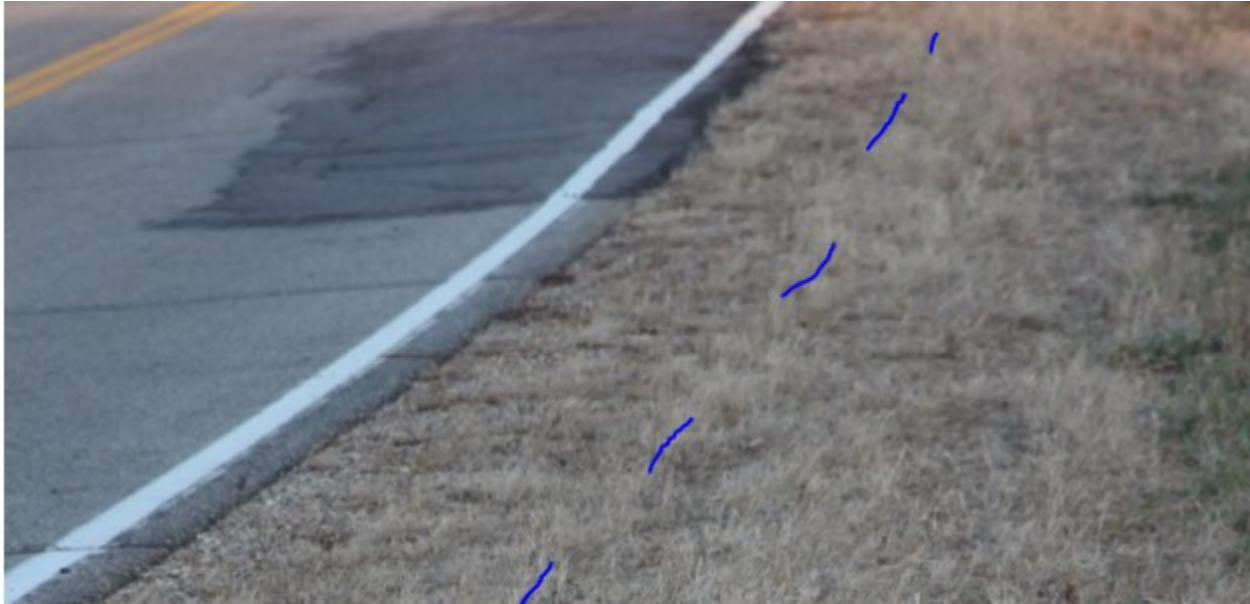
Figure 53: Example of Scenario #6 (from Murray Co. site)

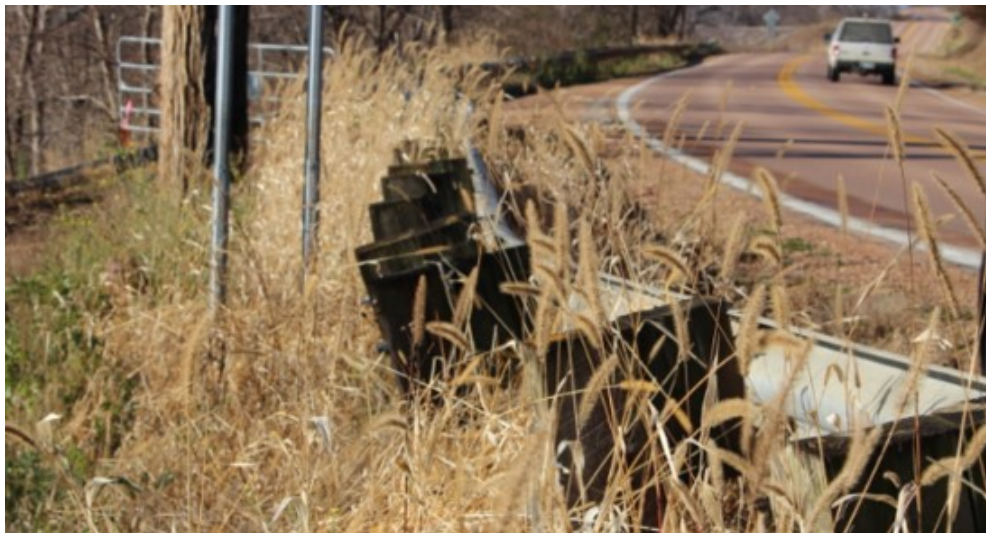
Figure 54: Example of Scenario #7 (from Carver Co. site)
